PRODUCT TESTING SERVICE

TCNA TEST REPORT NUMBER: TCNA-161-13

TEST SUBJECT MATERIAL: Identified by client as: “SurePly Premium UL”

TEST PROCEDURE: ASTM C627: “A Standard Test Method for Evaluating Ceramic Floor Tile Installation Systems Using the Robinson-Type Floor Tester”

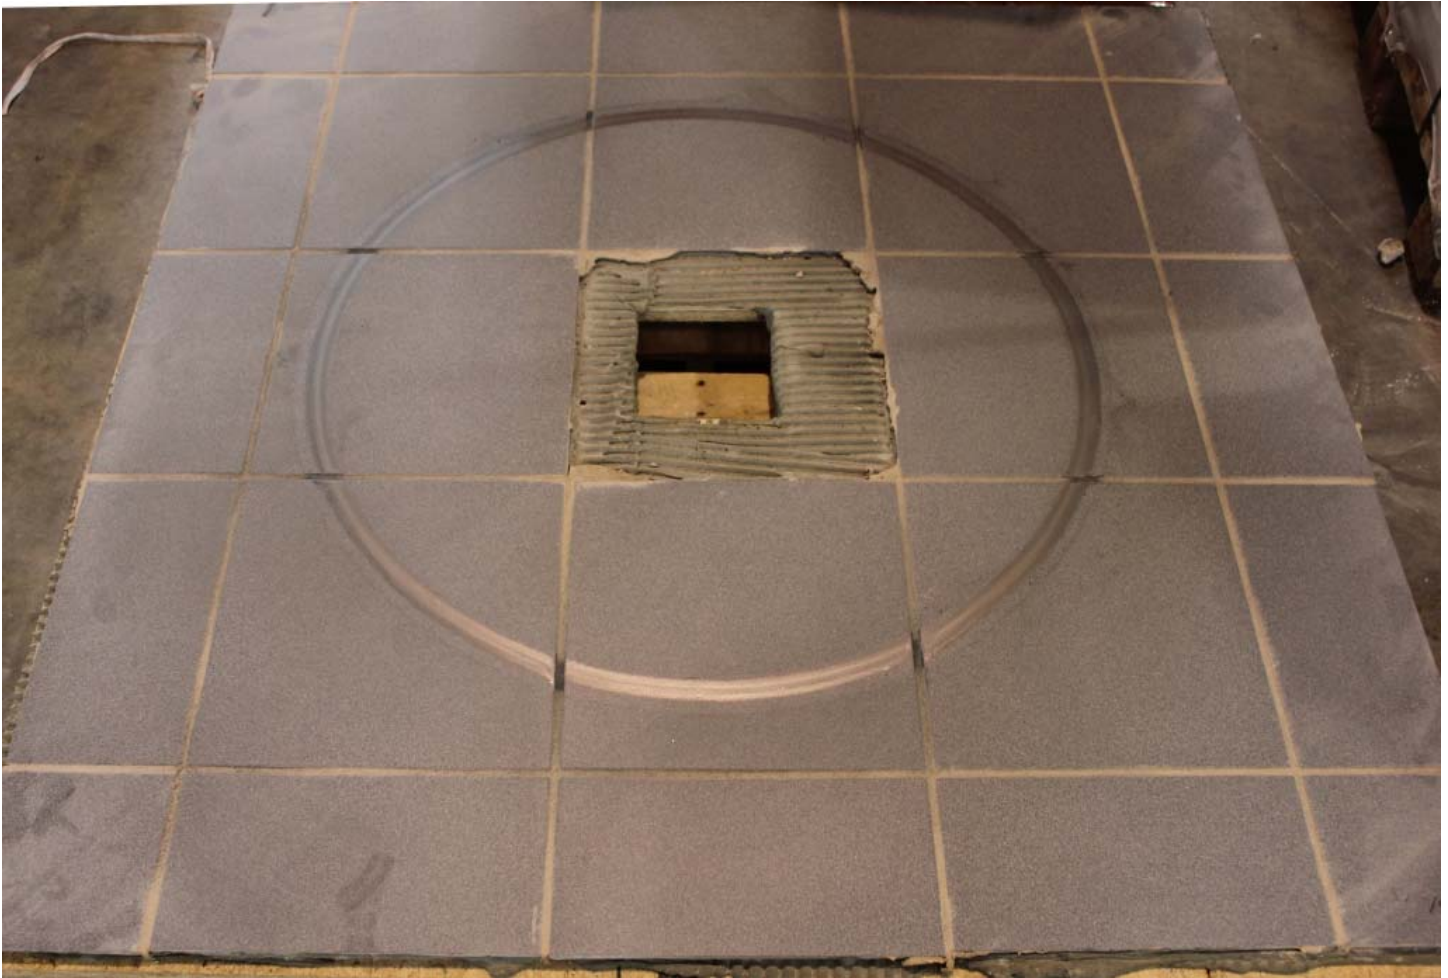
Image 1: Full assembly of the installed 12"x 12" Crossville Porcelain tile after testing (Figure 1)

The installation completed six cycles with no evidence of damage to the tiles or grout joints. At the completion of cycle seven (hard rubber wheels, three hundred pounds per wheel) there was one cracked grout joint. The test went on to continue the remaining seven cycles without further damage. All evaluation criteria were based on 8 tiles and 8 grout joints in the wheel path of the Robinson-Type Floor Tester.

In accordance with the Performance-Level Requirement Guide and Selection Table of the 2013 *TCNA Handbook for Ceramic, Glass, and Stone Tile Installation* (page 40), the installation is classified “EXTRA HEAVY”.

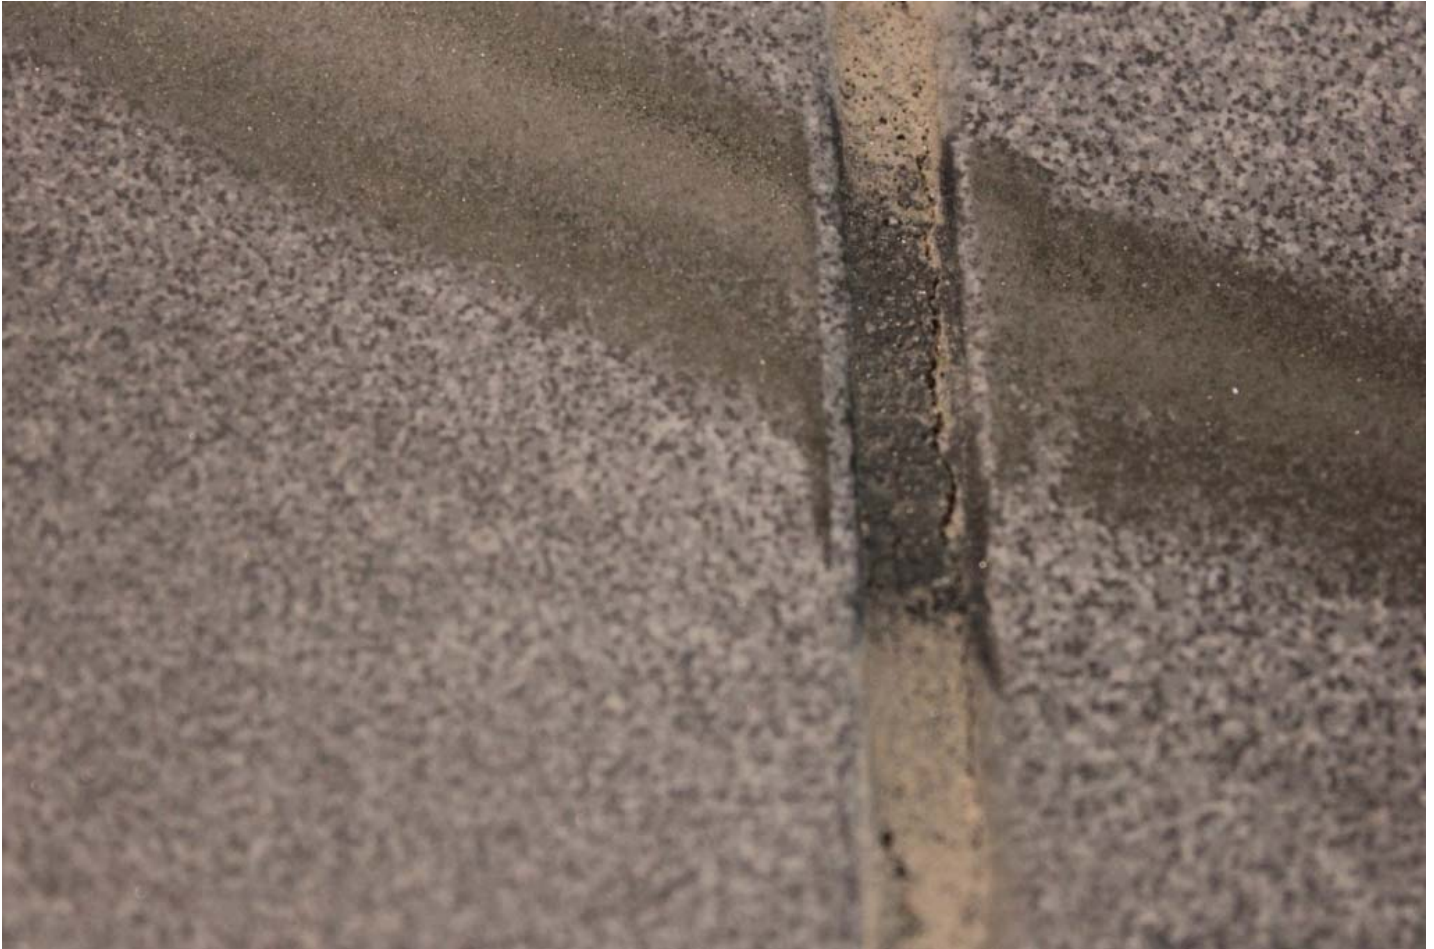
Image 2: Cracked grout joint
